INDOOR AIR QUALITY ASSESSMENT

**Department of Social Services
1 Arch Place
Greenfield, Massachusetts**

Prepared by:
Massachusetts Department of Public Health
Center for Environmental Health
Emergency Response/Indoor Air Quality Program
July 2005

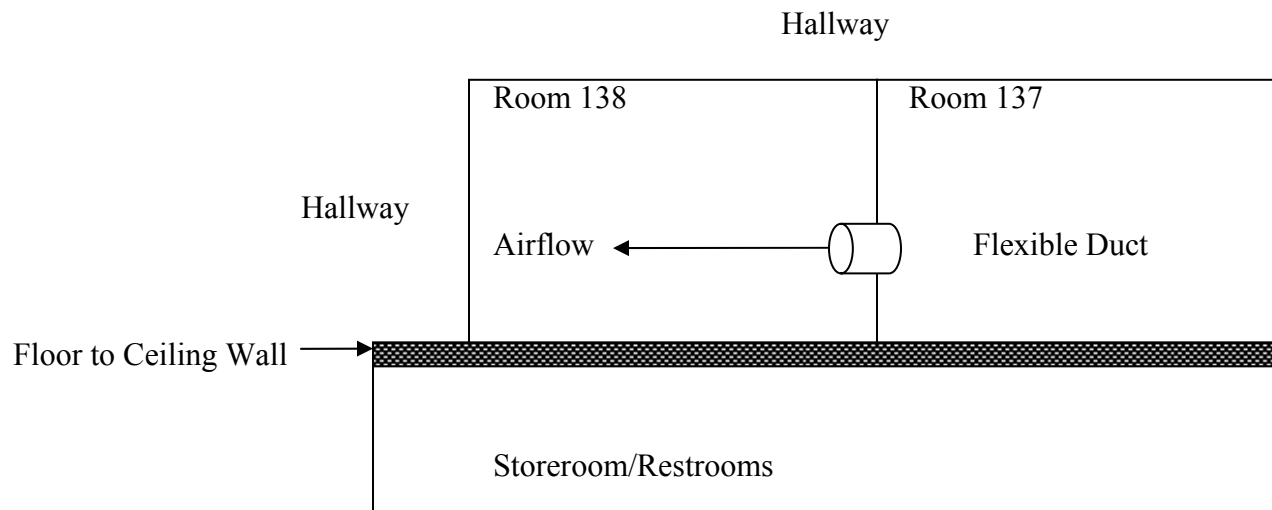
Figure 1
Airflow of Open Flexible Vent above Room 138

Several other conditions that can potentially affect indoor air quality were identified. DSS occupants reported a particular problem with room 138. In addition to moisture sampling, CEH staff examined the room as well as the space above the suspended ceiling (called the ceiling plenum). CEH staff noted that air was blowing from the ceiling plenum into the office when a ceiling tile was removed. Ceiling plenums are expected to either be depressurized when used as part of the return system in a building (in this case, it is not) or have neutral pressure. This pressurization was attributed to flexible ductwork that was not connected to the HVAC system (Picture 3). The unconnected flexible duct appeared to be a source of air movement above the ceiling in this area. Under these circumstances, settled dust, dirt and other accumulated debris above the suspended ceiling can be agitated by this airflow, which may then pass through the ceiling system into occupied areas. This phenomenon appears to be localized and possibly enhanced by the location of room 138, which is at the end of a row of offices (Figure 1). This room has two walls that are shared with a hallway and a third shared with the adjoining office (room 137). The fourth is a floor to roof decking wall that separates the DSS offices from the restaurant/public restrooms. The open flexible duct blows air from the wall shared with room 137 across the ceiling of room 138, and likely forces debris above the ceiling into the occupied space. Aerosolized dust, dirt and debris can be sources of respiratory irritants.

1. Reattach the flexible duct above room 138 to the appropriate air diffuser. If the flexible vent is not meant to be connected to an existing air diffuser, remove the flexible duct and seal its connection to the metal supply duct.

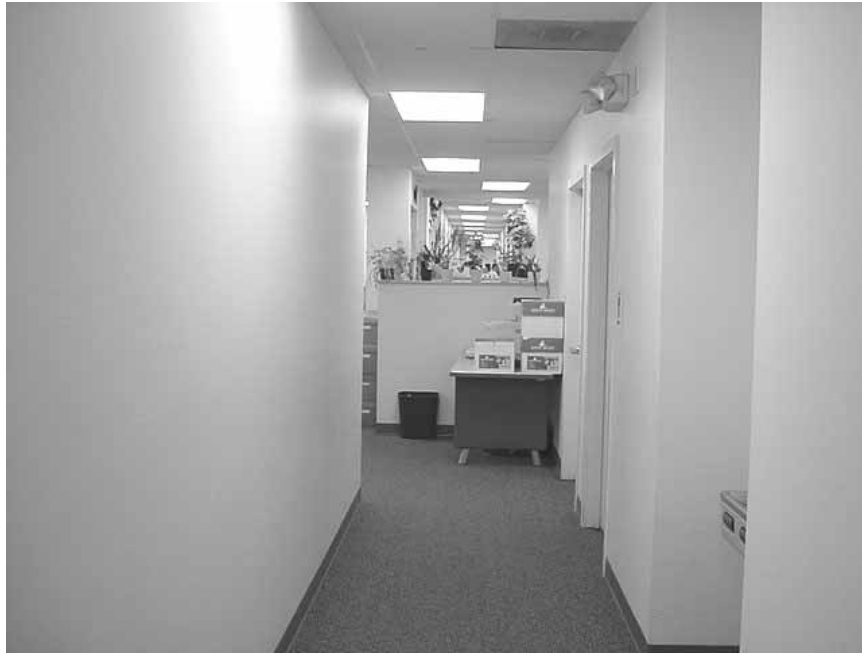
Picture 1

The DSS office occupies the first floor of a three-story office building constructed in 1993. The building is attached to a garage and a hardware store. Unoccupied office space is immediately adjacent to the garage on the DSS floor. A food establishment and public restrooms are located at the front of the building. The DSS office is divided into private offices and cubicles using four foot tall dividers (Picture 1).

Typical Floor Divider

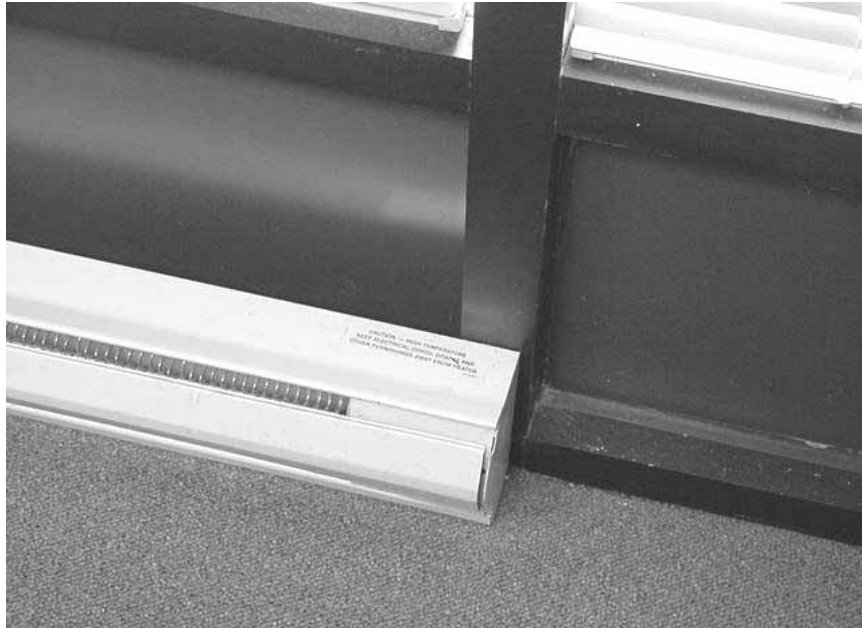
Picture 2

An office at the front of the building (room 123) appears to have an exterior wall that consists of a single metal panel (Picture 2). Without insulation, this panel would become chilled rapidly in cold weather and may be a source of condensation and contribute to thermal discomfort (cold complaints). Condensation is the collection of moisture on a surface that has a temperature below the dew point. The dew point is a temperature that is determined by air temperature and relative humidity. For example, at a temperature of 76°F and a relative humidity of 30 percent, the dew point for water to collect on a surface is approximately 43°F. At a temperature of 85°F and a relative humidity of 90 percent, the dew point for water to collect on a surface is approximately 82°F. Therefore, if a surface has a temperature under 83°F, water vapor will form droplets on that surface. Prolonged wetting of porous building materials by condensation can lead to subsequent mold growth.

Single Exterior Wall Panel behind Heater, Room 123

12. Install an insulated panel in the exterior wall of room 123 to reduce heat loss and prevent condensation.

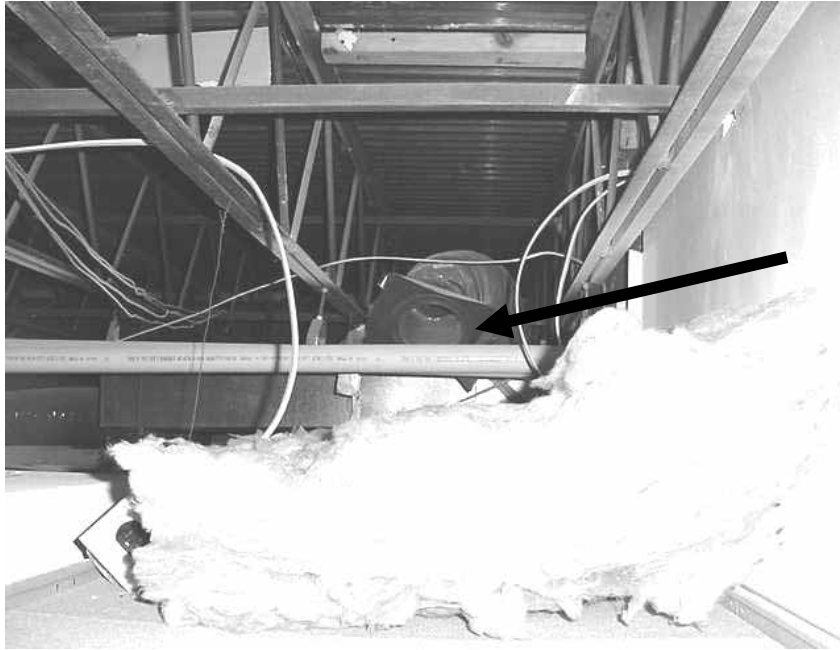
Picture 3

Disconnected Flexible Duct

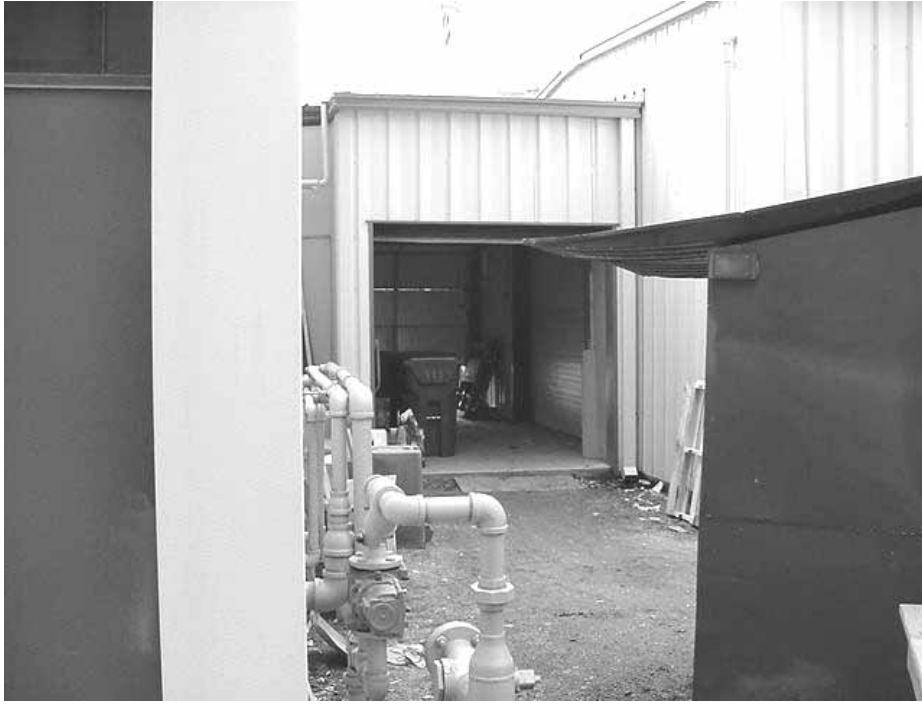
Picture 4

There appear to be two possible sources of vehicle exhaust odors. The north wall of the DSS building is connected to a garage. A door in the garage appears to open into the DSS building (Pictures 4 and 5). If this door and wall are not airtight, products of combustion from vehicles can penetrate into the building. Exhaust emissions can be a source of odors and particulates that can be irritating to the eyes, nose, throat and respiratory system. Another likely source is the operation of lawn mowing equipment along the rear wall of the building. As previously stated, fresh air intakes for the first floor are located along the rear wall of the building ten feet above the ground (Picture 6). If grass mowing is conducted or vehicles operate behind the building during office hours, vehicle exhaust, grass, pollen, dirt and other debris can become aerosolized, captured by the ventilation system and introduced into the building.

Garage Adjacent To DSS Offices

8. Render the door, door frame and shared wall of garage as airtight as possible using weather-stripping, door sweeps and sealing all open seams/holes with a fire rated sealant.

9. Determine if the garage contains a mechanical exhaust ventilation system, if not, a system should be installed in the garage to remove vehicle exhaust emissions.

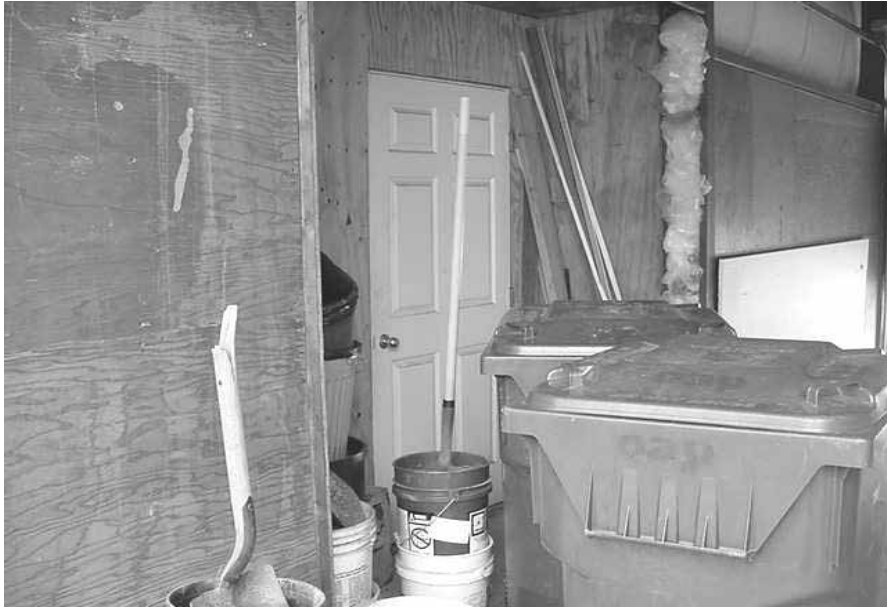
Picture 5

Door in Garage Shared With First Floor of DSS Offices

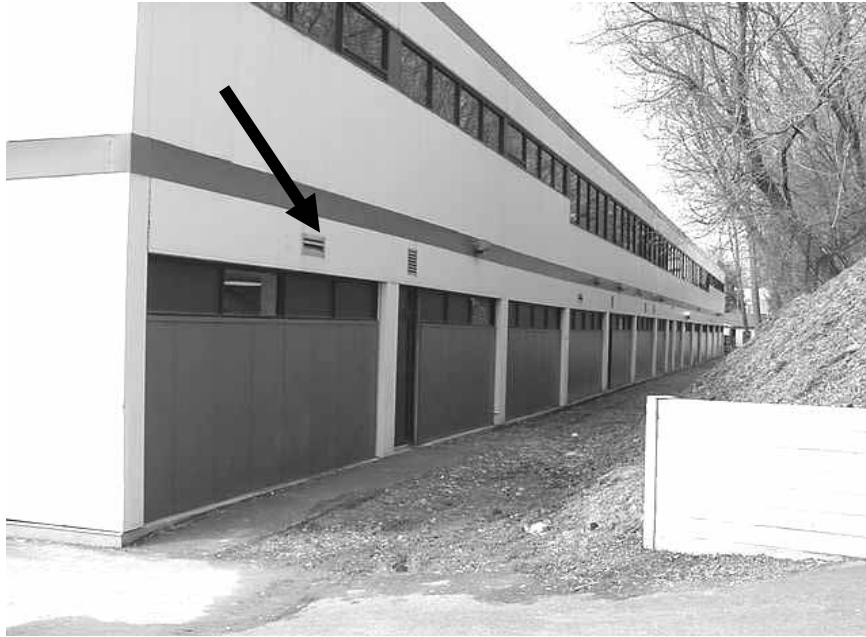
Picture 6

Air handling units are normally equipped with filters that strain particulates from airflow. Filters for this system are installed within the return vent frame and are of a low efficiency that provides a minimum of filtration. CEH staff could not determine whether fresh air intakes were equipped with air filters. If fresh, unfiltered air is drawn into the AHUs, particulates would likely be distributed into the DSS office. In order to decrease aerosolized particulates, disposable filters with an increased dust spot efficiency can be installed. The dust spot efficiency is the ability of a filter to remove particulates of a certain diameter from air passing through the filter. Filters that have been determined by ASHRAE to meet its standard for a dust spot efficiency of a minimum of 40 percent would be sufficient to reduce airborne particulates (Thornburg, D., 2000; MEHRC, 1997; ASHRAE, 1992). Note that increased filtration can reduce airflow produced through increased resistance (called pressure drop). Prior to any increase of filtration, each AHU should be evaluated by a ventilation engineer to ascertain whether it can maintain function with more efficient filters.

One of Three Likely Fresh Air Intake of DSS Offices

4. Examine fresh air supplies for filters. If no filters exist, install a means to install filters for fresh air intakes.
5. Change filters as per the manufacture's instructions or more frequently if needed.

7. Make arrangements for grass cutting to be conducted after DSS office hours. If not feasible, minimize fresh air intake temporarily until grass cutting or vehicle activity is complete.
